NATIONAL TECHNICAL UNIVERSITY OF ATHENS

Integrated Diagnostic Research Project and Strategic Planning for Materials, Interventions Conservation and Rehabilitation of the Holy Edicule of the Holy Sepulchre in the Holy Church of the Resurrection in Jerusalem

**Final Report Presentation,
27 January 2016, Consulate General of Greece in Jerusalem
19 February 2016, Greek-Orthodox Patriarchate of Jerusalem
8 March 2016, Zappeion Hall, Athens**

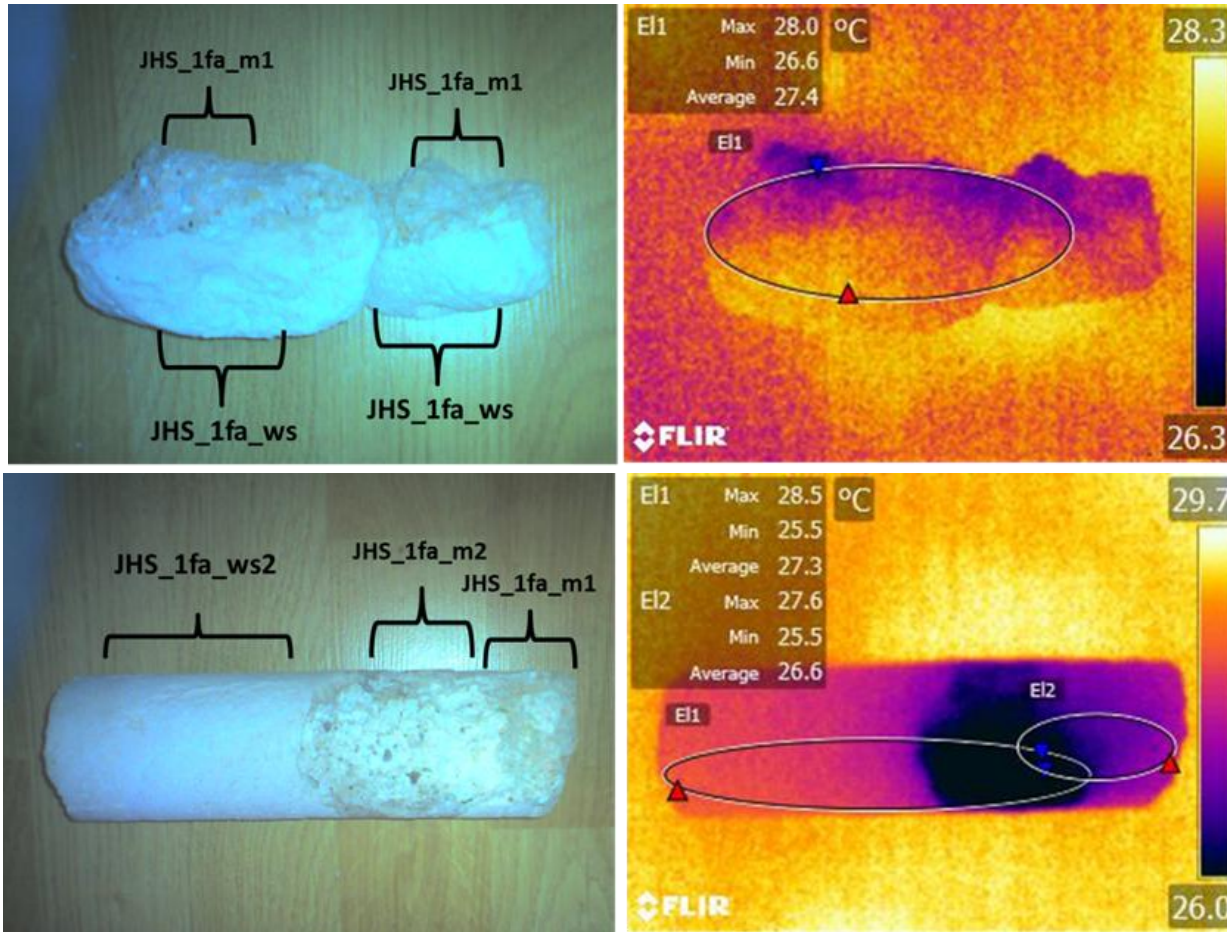
NON DESTRUCTIVE TESTING – INFRARED THERMOGRAPHY

INCOMPATIBILITY BETWEEN BUILDING MATERIALS (STONES - MORTARS)

- Mortars have lower temperature than the stone
- Maximum temperature difference 3 °C
- Indication of humidity presence

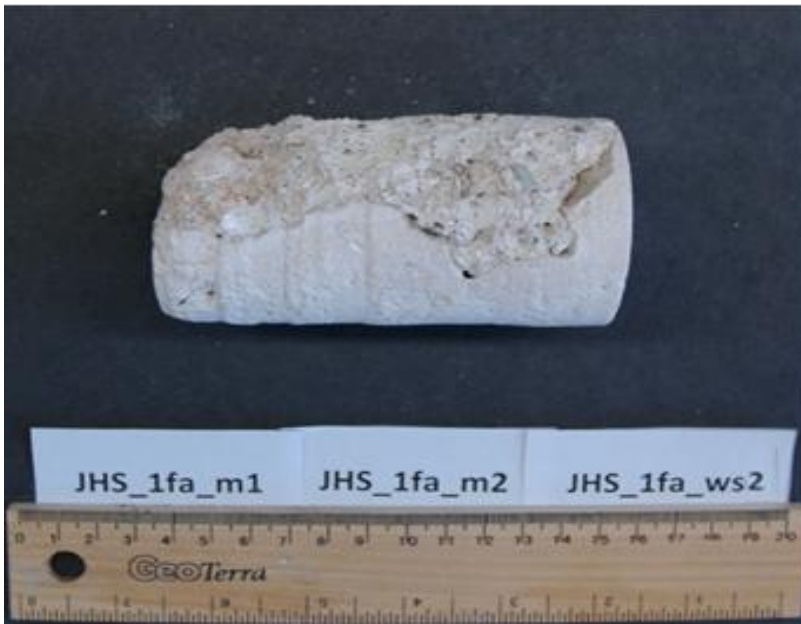
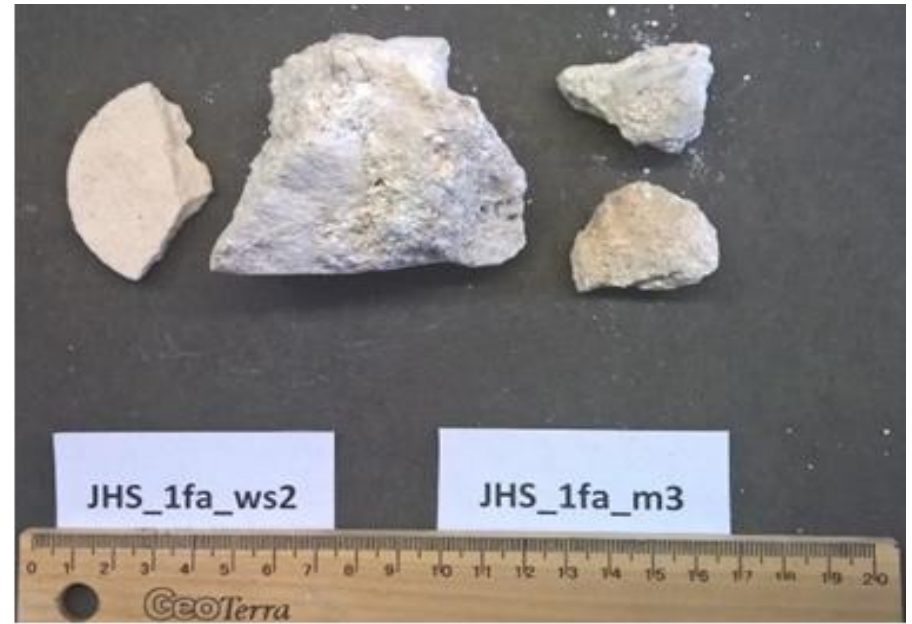
CHARACTERIZATION OF THE HISTORICAL MORTARS OF THE HOLY AEDICULE OF THE HOLY SEPULCHRE

Historical Mortar Characteristics – Holy Aedicule of the Holy Sepulchre

- ❖ *Binder of calcitic nature*
- ❖ *Aggregates the combination of sands or sand and crushed brick*
- ❖ *The mortars can be characterized as slightly hydraulic (pozzolan mortars). The hydraulic character is attributed to CAH (calcium aluminate salts which develop during the setting and hardening of hydraulic lime and originated during the firing of a marly limestone. This is the main cause for their deterioration, due to the water inflow from the opening in the dome, and also due to rising damp and condensation*

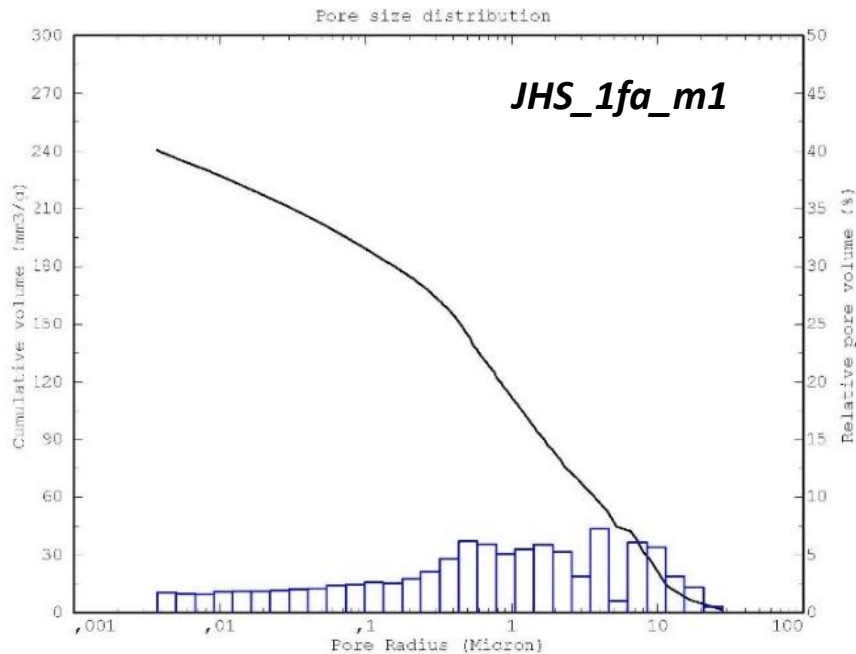
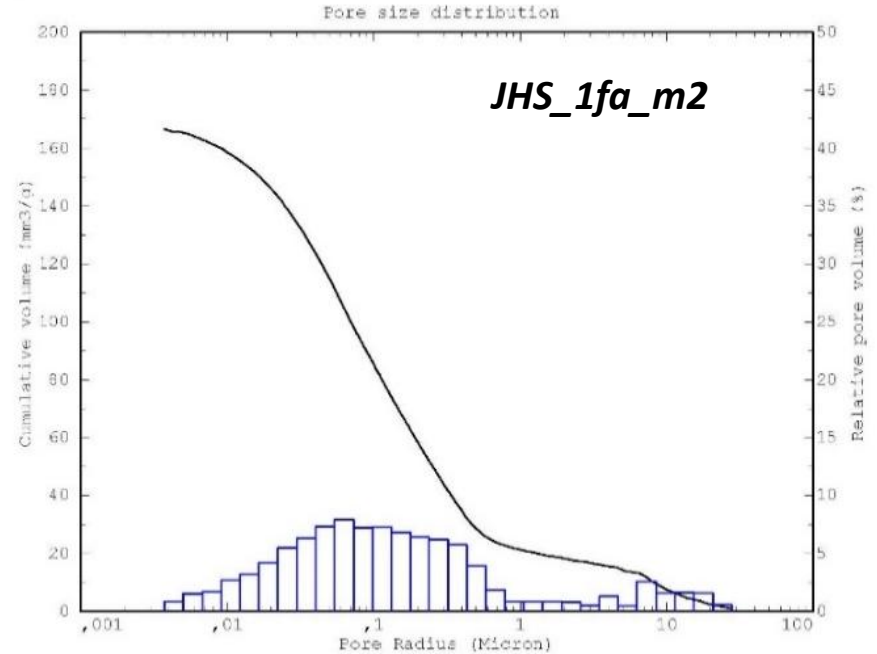
MICROSTRUCTURE CHARACTERISTICS

Total cumulative volume:	166.7-570.5 (mm³/g)
Apparent density:	1.0 – 1.7 (g/cm³)
Average pore radius:	0.1 – 0.8 (μm)
Specific surface area:	1.9 – 8.0 (m²/g)
Total Porosity:	28.4 – 56.0 %

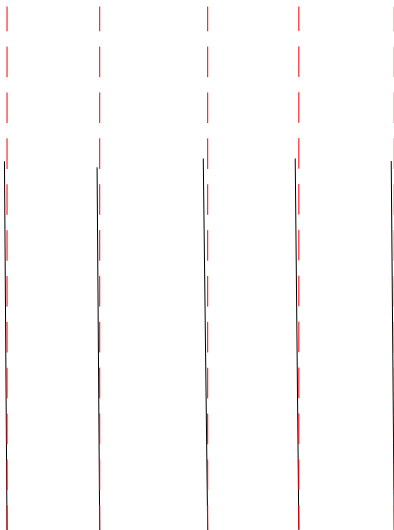
Deformations of the metal supportive beams

The measurements of the points along the ten metal supportive beams revealed that there is strong deformation both vertically as well as horizontally. Vertically deviations up to 23" are observed and horizontally the beams present a bending tendency, i.e. the presence of a stress bow

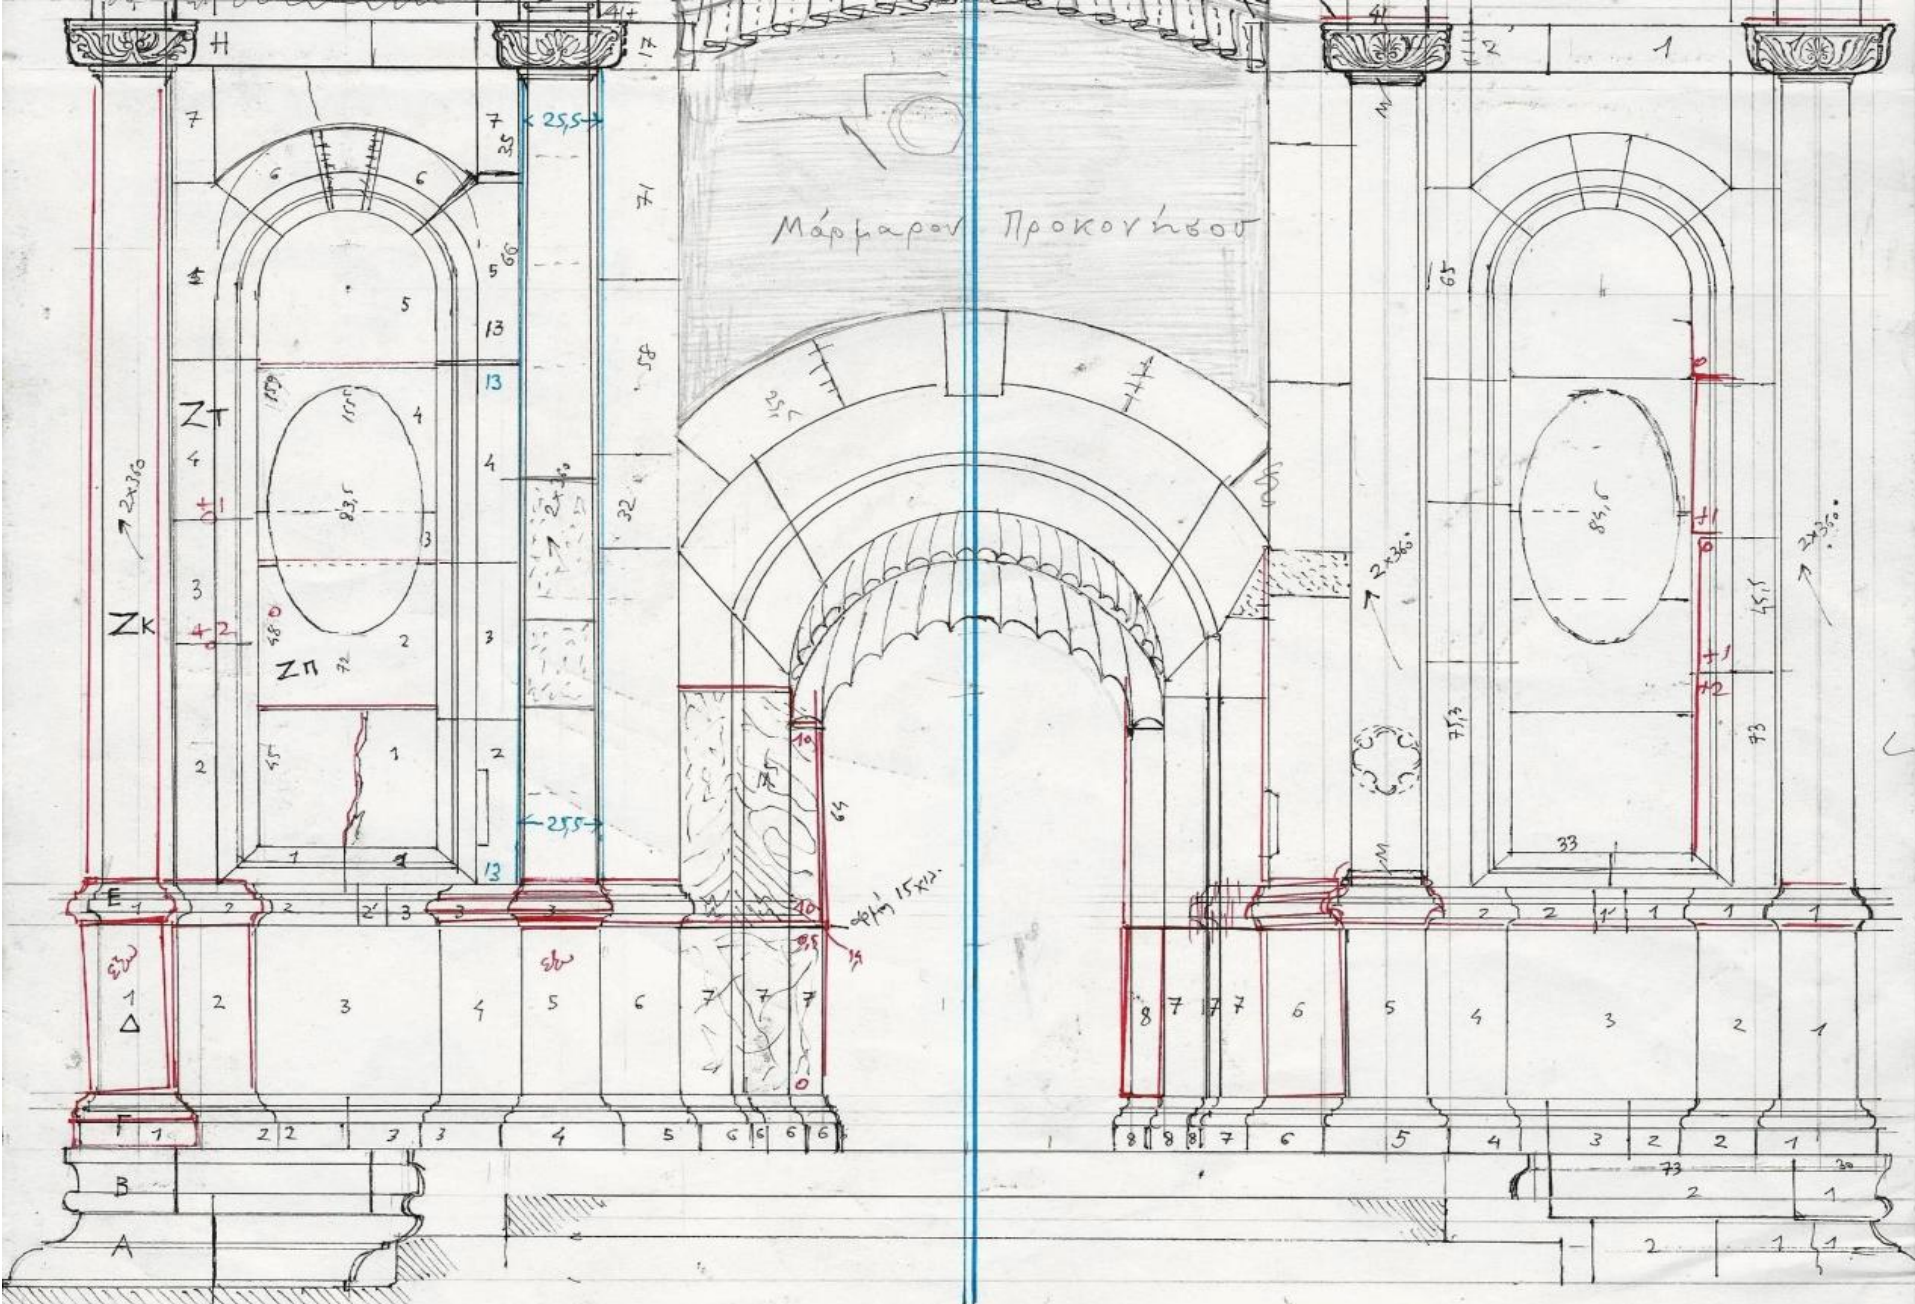
Dr. T2 Holy Aedicule, drawing of the façade that describes the boundaries and the movement of each stone, vertical and horizontal design sections (Em. Korres, 2015).

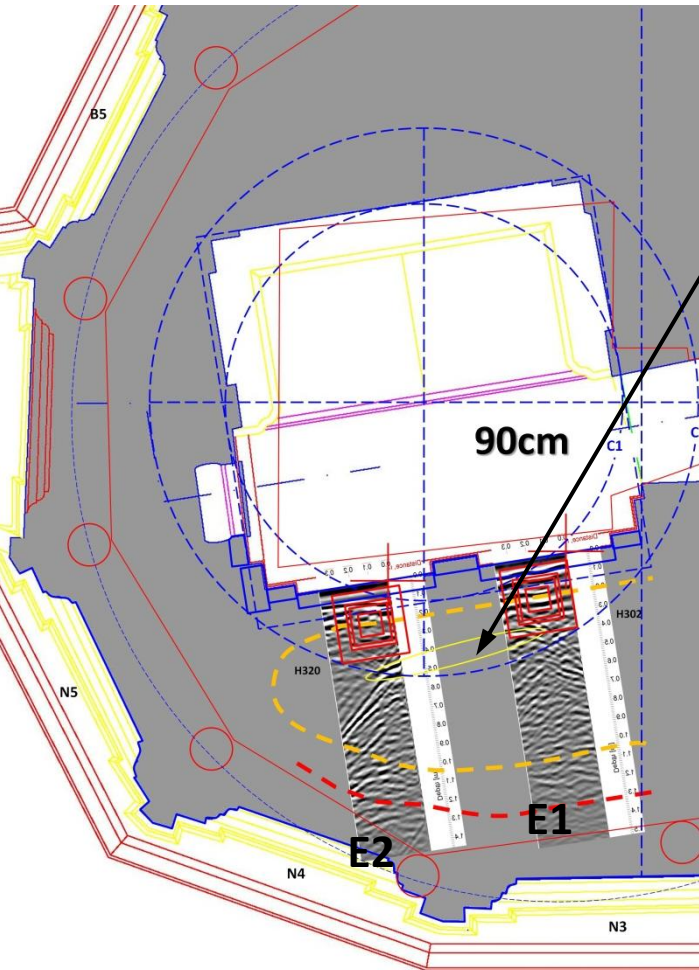
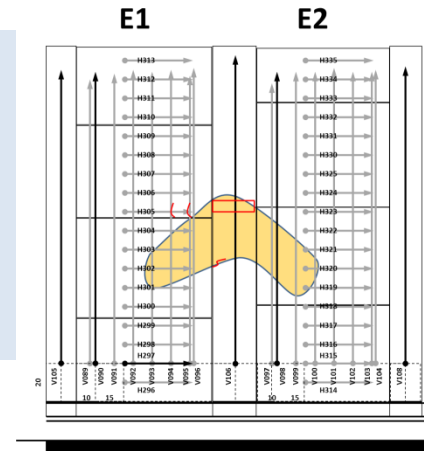
Presence of a inhomogeneity, which it is theorized to correspond to an **internal fracture within the Holy Rock** at areas E1 and E2, between the height levels 80-120cm and with a form of an inverted “v”

A possible interpretation of the mechanism of formation of this internal fracture is that since these pillars are half-founded on the rock and half-found on the masonry between the rock and the interior panel, during dynamic loading, the intensity of the applied stresses at this area, possibly led to the “internal detachment” of part of the rock.

At the boundaries of this area, there are **macroscopically observed** – at the surface of the panel – cracks and displacements, the location of which corresponds satisfactorily with the boundaries of the theorized internal fracture.

Necessitate the **design of strengthening interventions within the Holy Tomb too and in particular at its southern part**, i.e. areas E1 and E2, so as to avoid possible static problems of the roof structure above the Holy Tomb

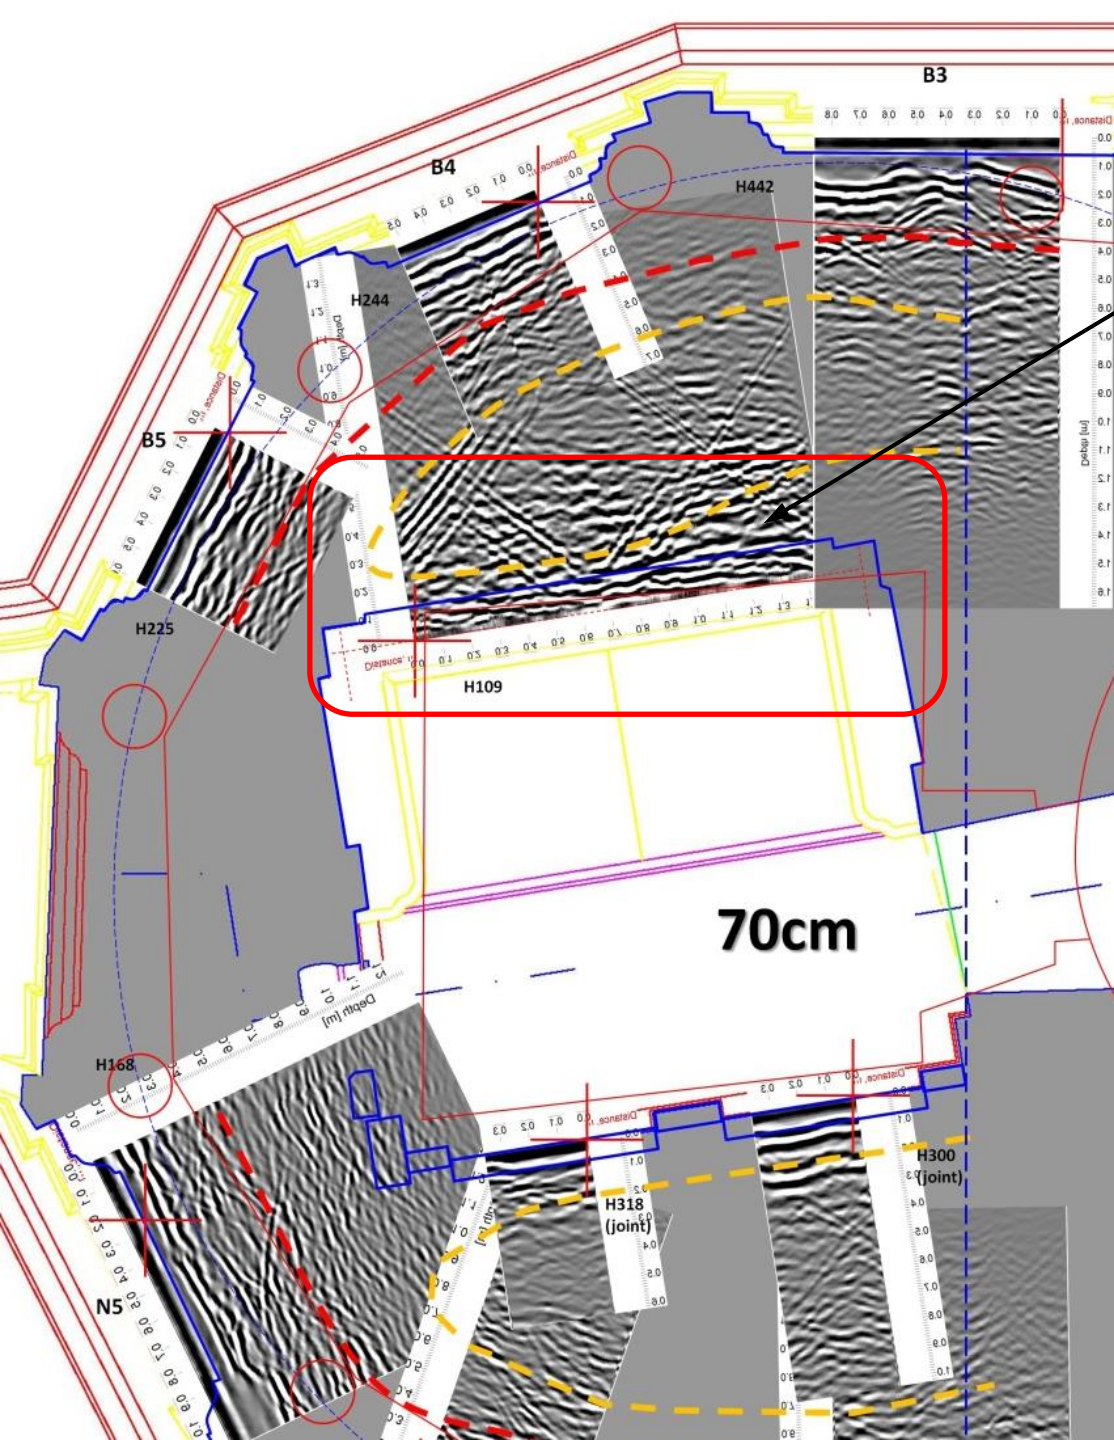
The reflections possibly correspond to the loss of cohesion with the masonry behind and above the arcosolium, between the interior marbles and the rock.

It should be noted that these areas occur below corresponding pillars such as those of areas E1 and E2, although, due to the lack of sufficient horizontal scans from the northern interior, no safe correlation could be performed.

The area behind and above Jesus tomb is in need of further attention and possibly requires strengthening interventions, as in areas E1 and E2, although, due to accessibility limitations, any such work will be difficult to implement

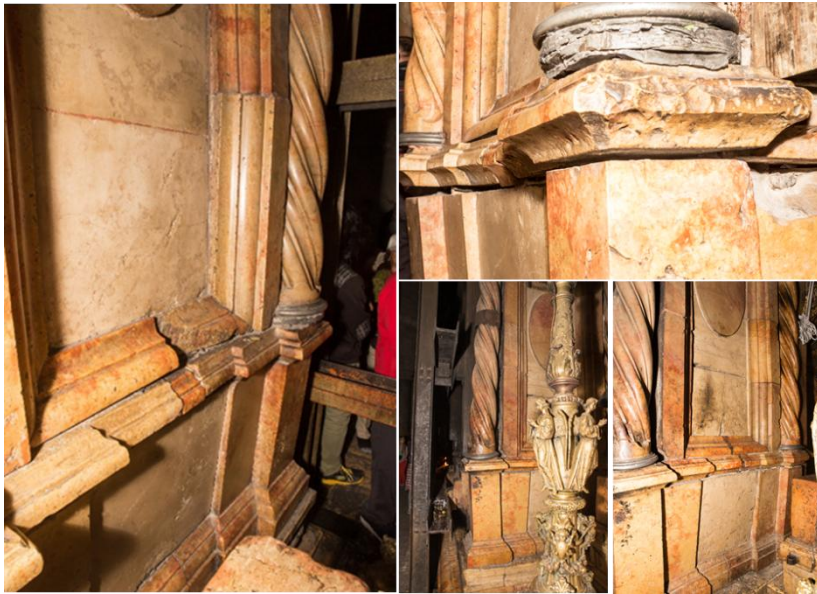
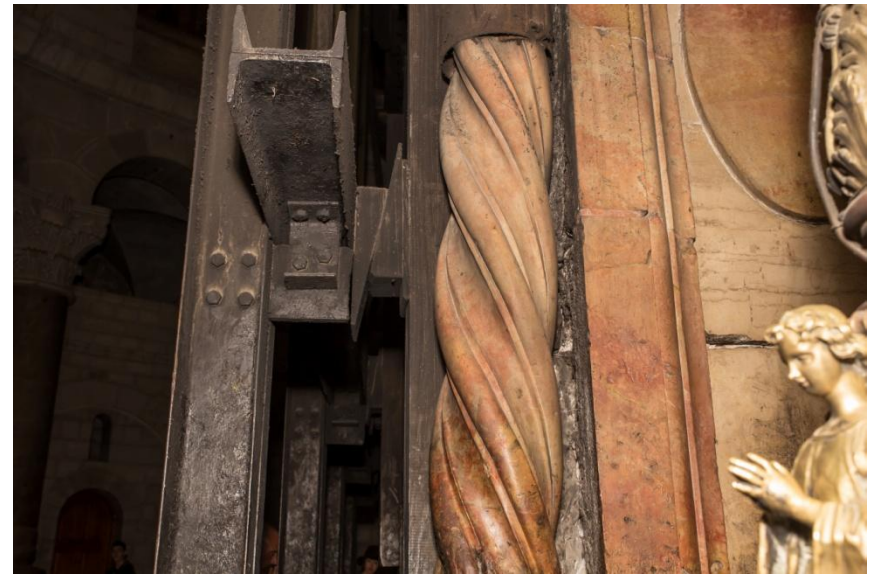
The exterior surfaces of the monument (marble elements and facades) present extensive deformations. These can have a significant impact on the static behavior of the Holy Aedicule, imparting additional loads on building materials contributing negatively to the longevity of the monument, therefore, the cause must be identified and addressed.

The cause of the deformation is the deterioration of the mortars. Their hydraulic character is attributed to CAH (aluminates salts of calcium), that develop during the setting and the hardening of the hydraulic lime that is produced by the burning of the marl limestones. This is the main reason of their deterioration, from the infiltration of drainwater from the opening of the dome, but also from rising damp and the condensation and respiration of the pilgrims

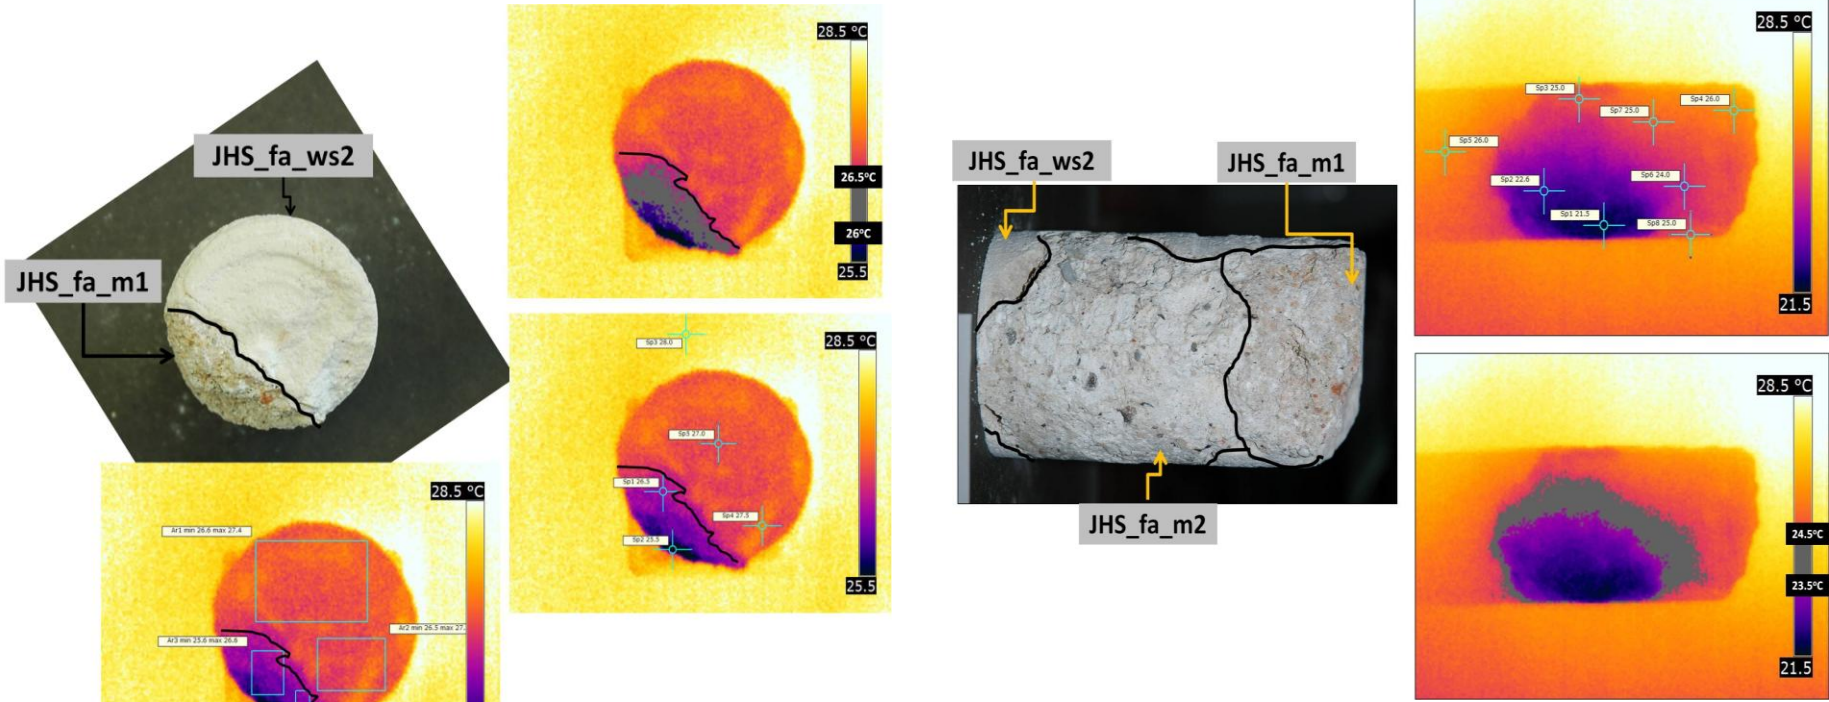
Infrared thermography of part of the drilling samples of the masonry

Physicochemical incompatibility between the joint mortars and the stone

From the above infrared thermography image, coming from a part of the façade core sample, the physicochemical incompatibility between the historic grouting mortar and the building stone is found. Due to its erosion, mortar performativity has been lost attributing lower temperatures than the building stone within a temperature range of 3 °C, whereas the 1 °C temperature range area indicates the moisture transportation procedure from the rich ettringite lime mortar JHS_fa_m2 to the building stone JHS_1fa_ws and lime mortar JHS_fa_m1.

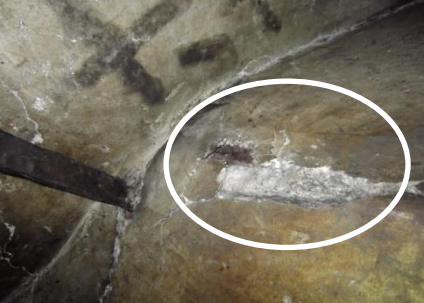
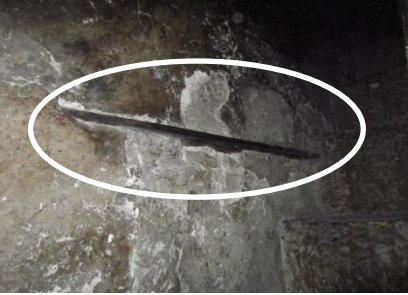
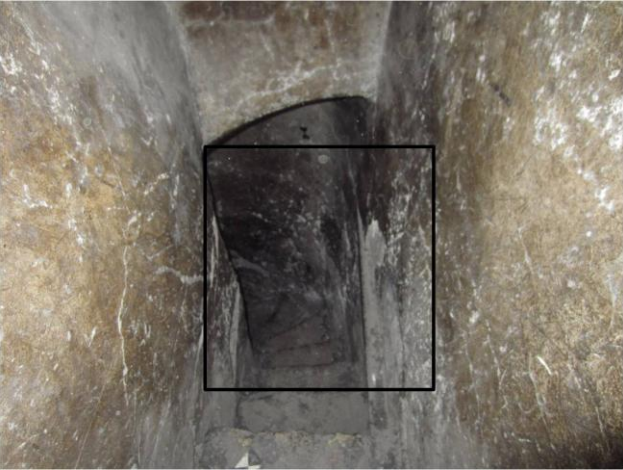
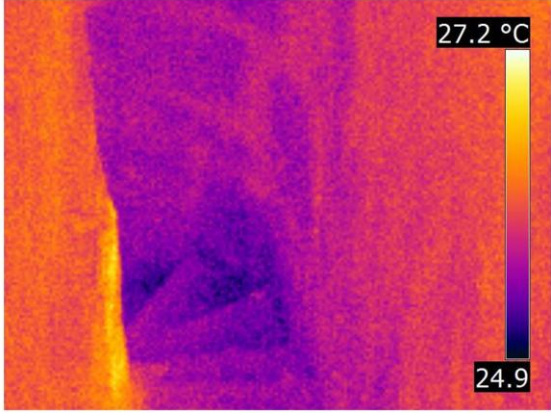
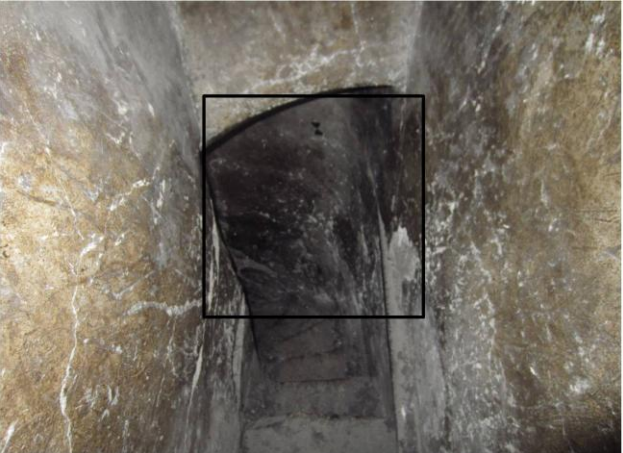
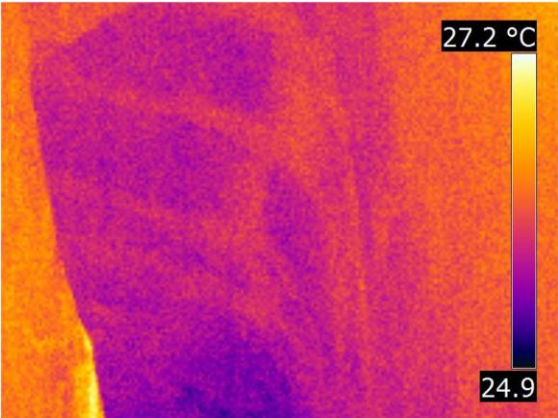
Infrared thermography of the internal sidewall of the masonry of the eastern and southern side the staircase leading to the terrace

The metallic elements have been oxidized and subsequently have swelled. Due to this, plaster cracking has been occurred causing, in turn, partial material detachment.

During the IR-Thermal inspection of the area (Figure 31) along the cracks and around the areas where material detachment has taken place, higher temperature, following the decay and a metallic mesh patterns, is observed.

This makes possible the existence of metallic elements invisible macroscopically under the plaster

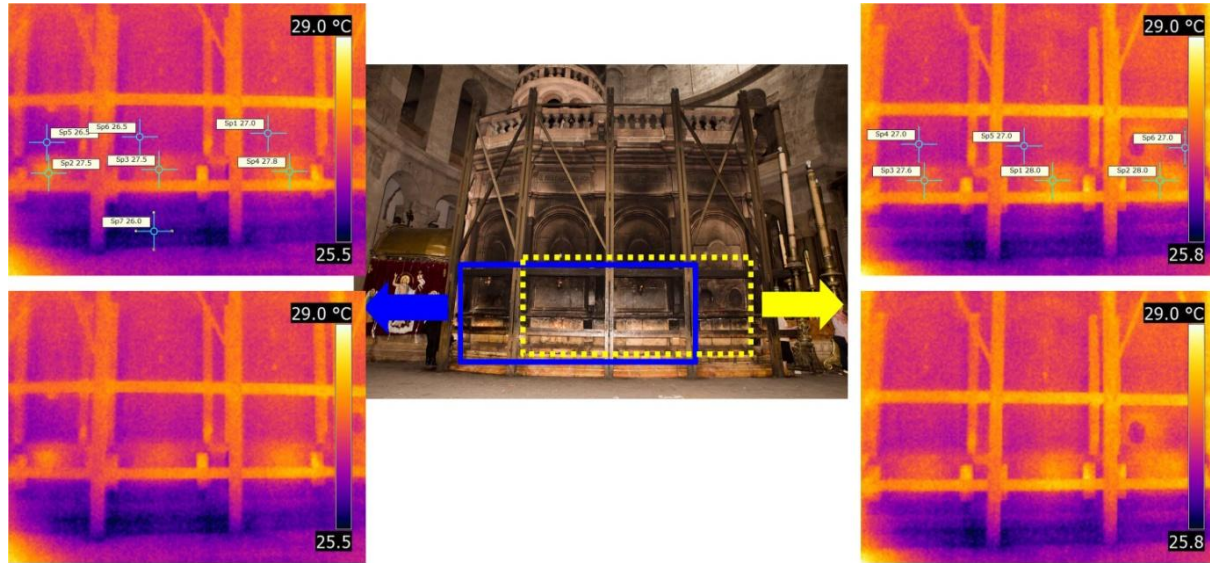
Infrared thermography of the southern façade of the Holy Aedicule

The aforementioned action, taking place in a daily basis causes corresponding changes in the thermo-hygrometric behaviour of the building materials of the masonry, accelerating their deterioration.

3 hours after burning the candles out

It is clear that the burning candles or/and the oil-lamps being in contact or having close proximity to the architectural surfaces of the Holy Aedicule is prohibitive and is suggested the particular action to take place at a sufficient distance from it.

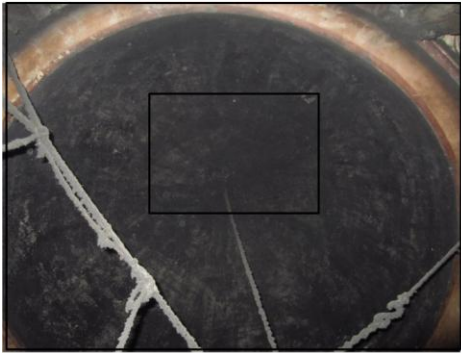
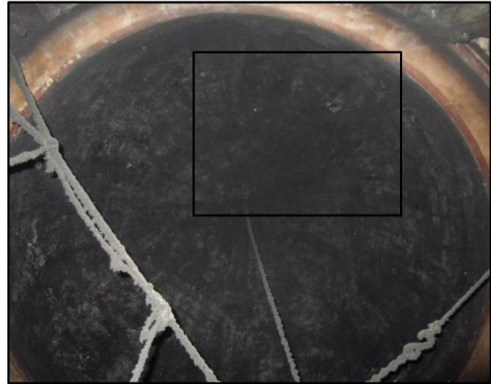
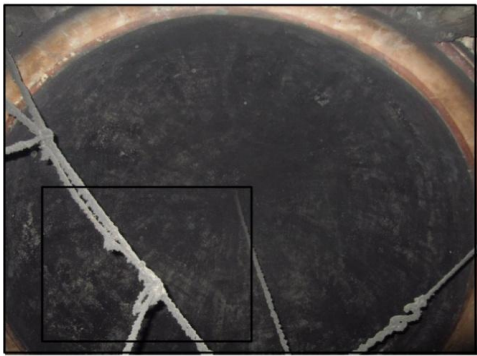
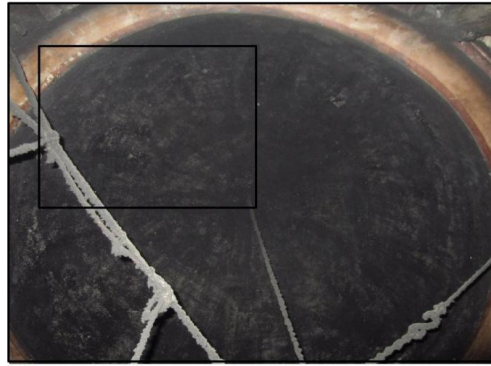
IR-Thermal inspection of the dome and the terrace of the Holy Aedicule of the Church of the Holy Sepulchre

As seen from the Thermographs of the isotherms, there is observed heat accumulation in the centre of the dome above the Tomb's chamber, resulting in approximately 1 °C higher temperature in the area around the centre.

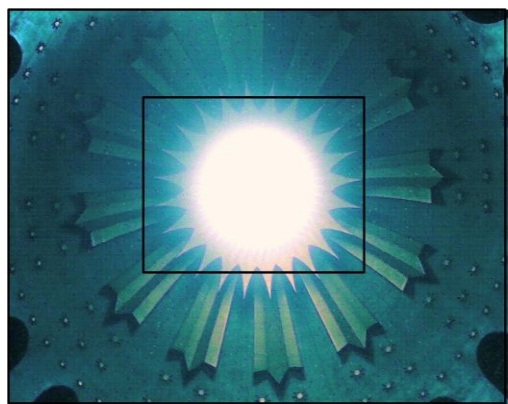
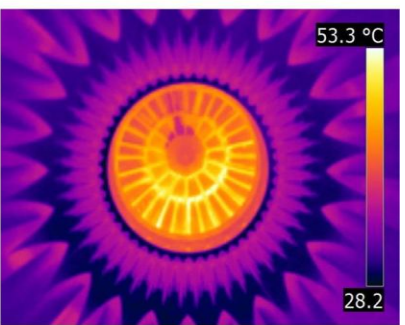
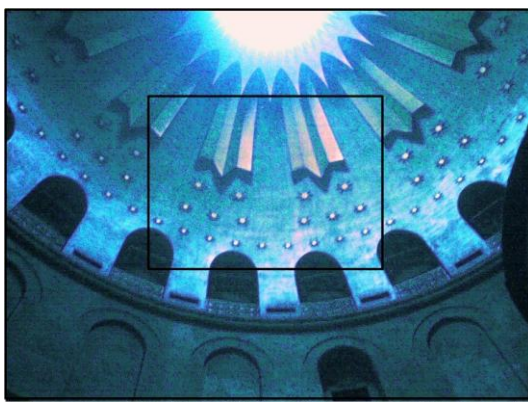
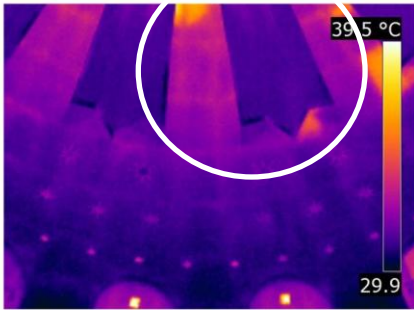
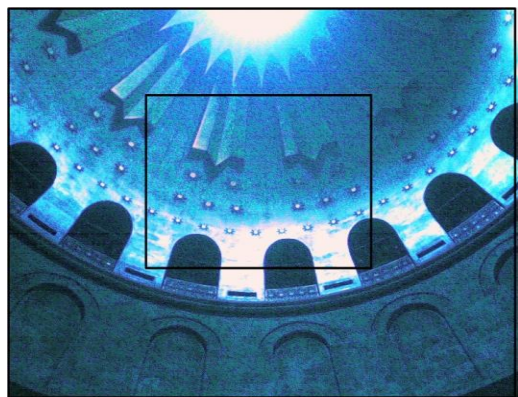
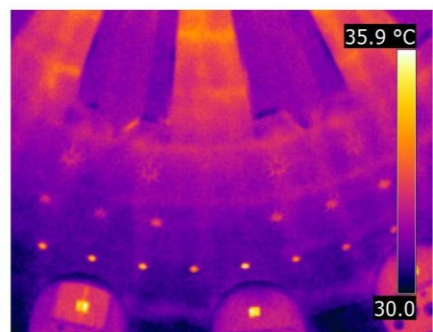
IR-Thermal inspection of the Rotunda dome

The IR-Thermal analysis managed to map the metal skeleton of the concrete dome of the Rotunda, as well as structural elements, not visible macroscopically, some of which might need further investigation with respect their preservation state

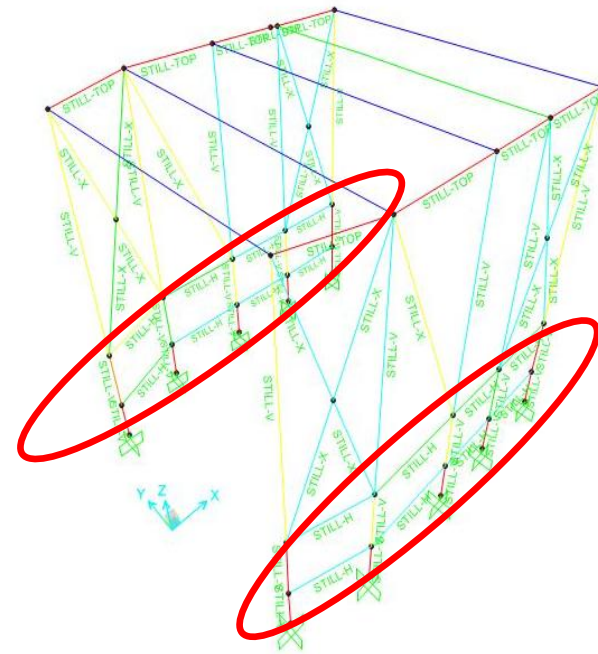
The wedging and the tendon forces are applied.

Failure of members (in red cycle)

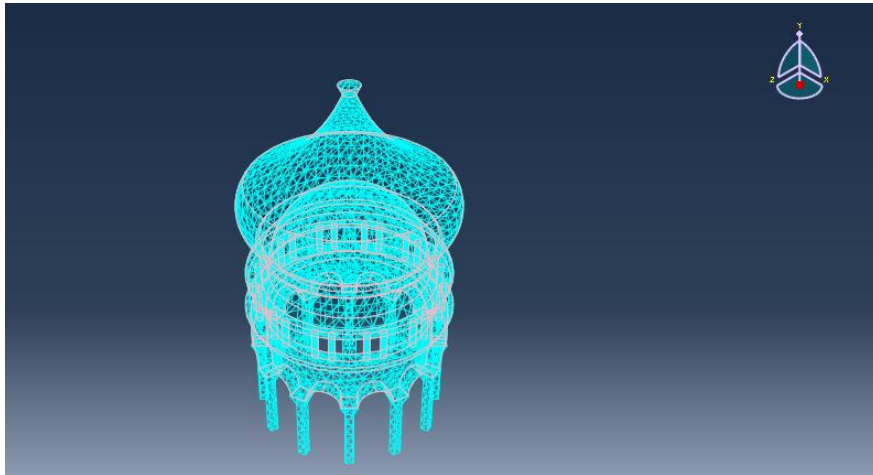
Outer Dome Finite Element Model Seismic Loading

Exceedance of tensile strength at column base
(in red cycle)

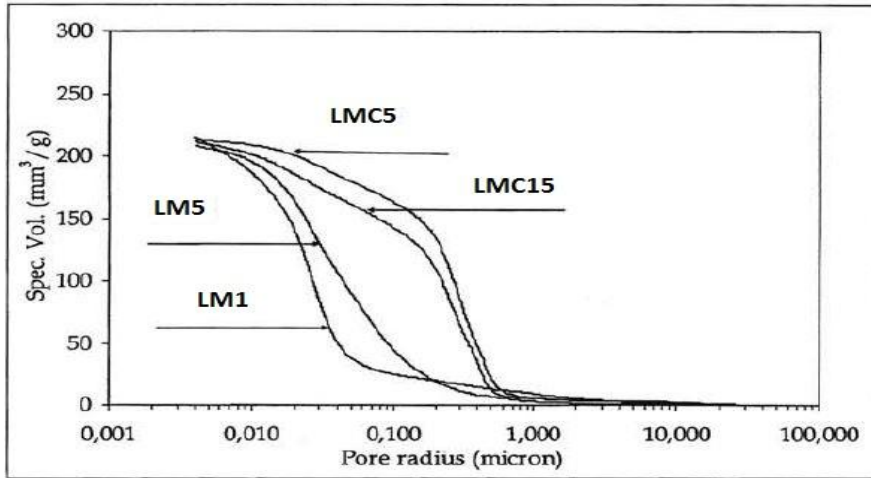
ACCEPTABILITY CRITERIA 3. Examination of microstructure through the use of mercury intrusion porosimetry, for the assessment of compatibility

Microstructure characteristics (total cumulative volume in relation to average pore radius) for different categories of mortars and concretes

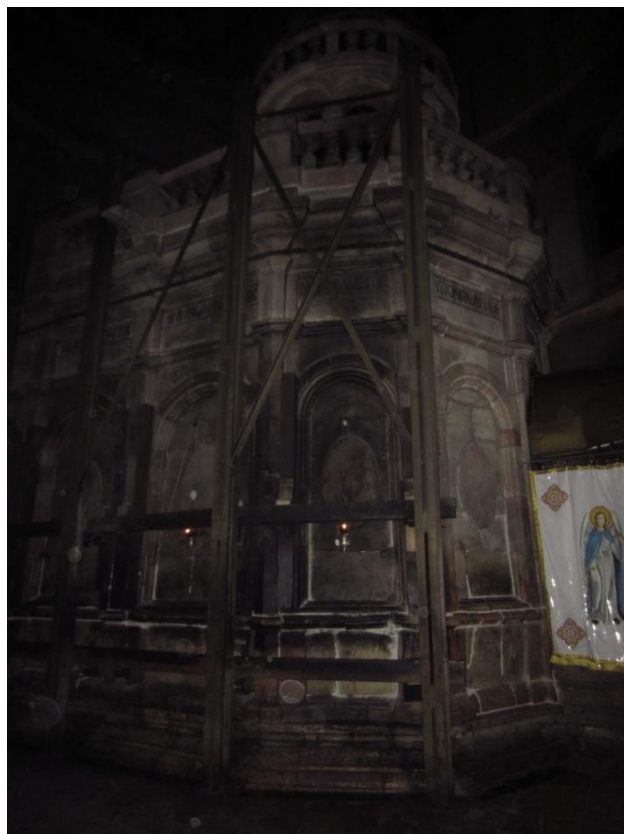
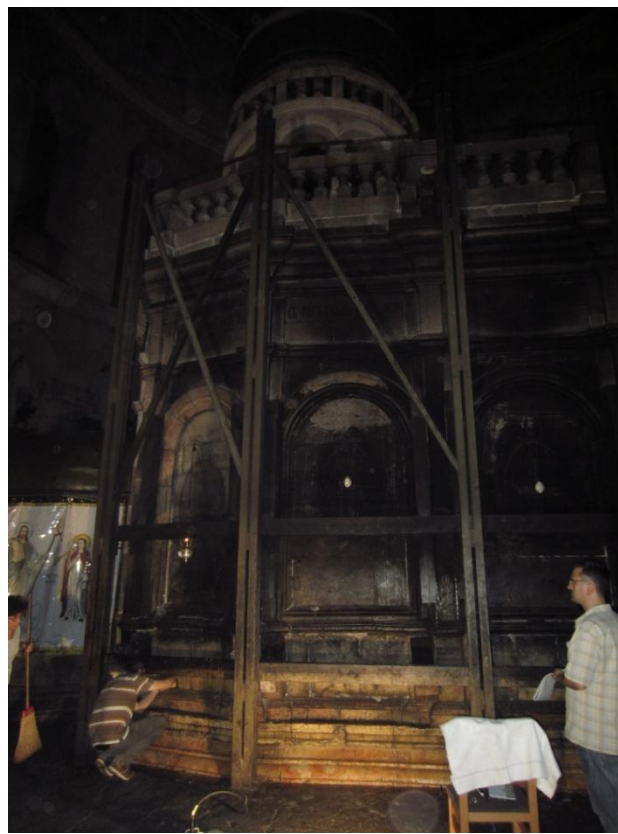
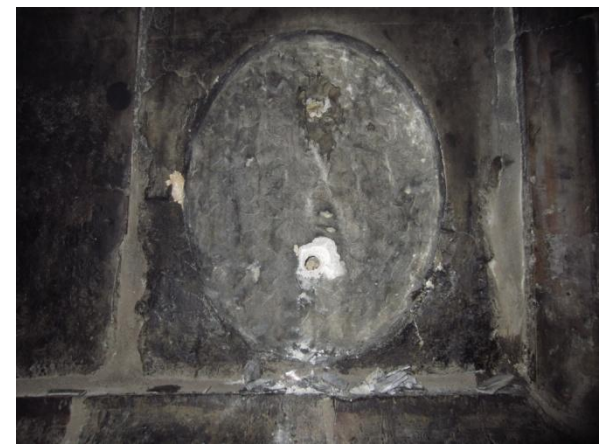
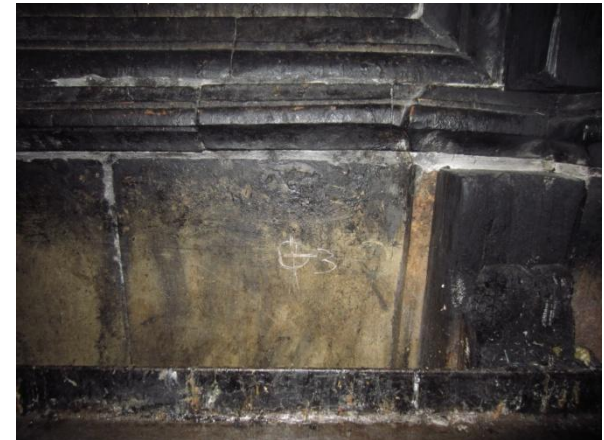
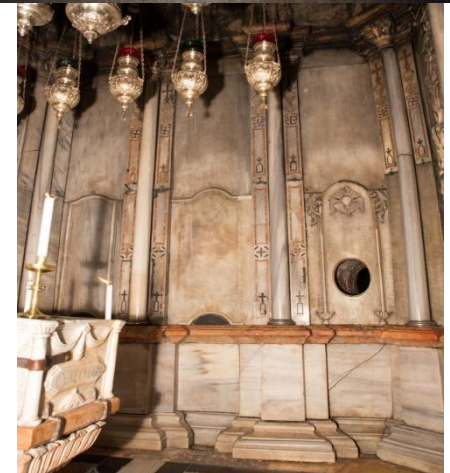
The main decay patterns presenting in all the above mentioned architectural surfaces are **oily depositions** and extended **black depositions** which are primarily consisted of soot particles. Candles' burning close to or even in contact to the architectural surfaces is the major factor for the presence of these decay patterns.

However, the sulphation of stones surface cannot be excluded.

Black and oily depositions not only alter the visual appearance of the stonework due to the discoloration development, but also lead to further decay.

The accumulation of black depositions on stone facings acts as catalyst for degradation processes, accelerating further decay.

Therefore, the employment of **cleaning** becomes essential not only for the present conservation of deteriorated areas, but also for **preventing further erosion phenomena**.

The following cleaning methods are selected for the conservation of the architectural surfaces of the Holy Selpuchre, based on the stone facings' preservation state (building material and decay), the international common practice, as well as the former experience of NTUA:

- application of **AB57 poultice with triethanolamine and ammonia**,
- application of **poultice of ion exchange resin and/or sepiolite with water solution of ammonium bicarbonate**,
- application of a **soap-water emulsion** and then spraying **oxalic acid solution** of low concentration. The application of the **oxalic acid solution protects** the architectural surfaces from further decay, because of **its hydrophobic action**.
- application of a **wet micro-blasting method**, where spherical particles of CaCO_3 (diameter $<80\mu\text{m}$), are springing with a maximum function pressure of 0.5bar The proportion of water to spherical particles of CaCO_3 in the device's commixture barrel should be 3:1.
